## Evaluation of the Effectiveness of Different Photoluminescent Stairwell Installations for the Evacuation of Office Building Occupants

### **IRC-RR-232**

Proulx, G.; Bénichou, N.; Hum, J.K.; Restivo,  
K.N.

July 6, 2007

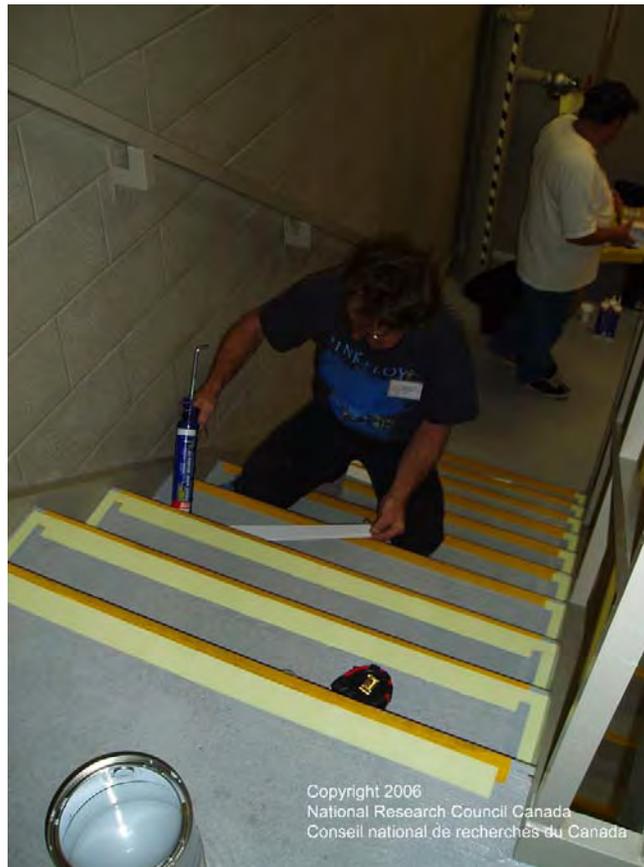
Figure 8: Stairwell installations

Three stairwells were equipped with a photoluminescent material installation, comprising the marking of 7 elements, see Figure 8.

Table 1 summarizes the elements that were installed in the tested stairwells. Signs and markings were essentially the same for the three PLM stairwells except for the markings on the steps. Stairwell A had “L” markers at the edge of each step representing an installation similar to New York City Local Law 26 for existing buildings, except that marking on the handrail was added, which is not a requirement in New York City. Stairwell E represented New York City requirements for new buildings, with continuous marking of 1” width across each step and handrail marking. The installation in Stairwell G combined the “L” shaped markers, a 2” wide line across each step, and a 2” wide demarcation line around the landing, which was a suggestion made by the executive

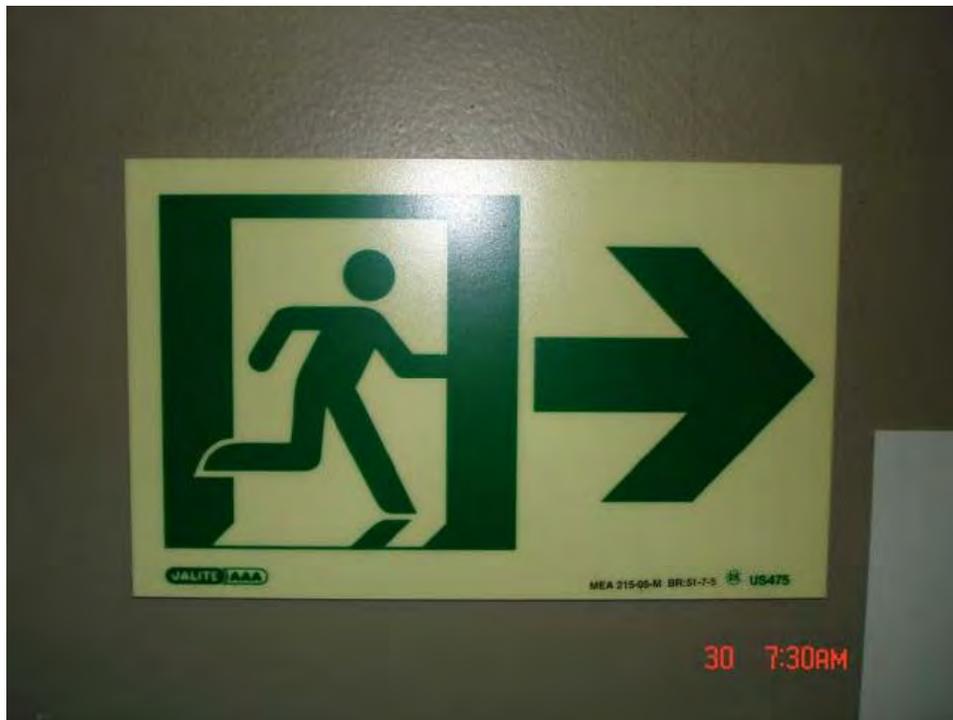
Figure 19: Directional sign with the running-man

There was a statistical difference among stairwells for the visibility of directional signs ( $\chi^2 = 37.183(9)$ ,  $p < 0.001$ ). Stairwells C and G had no difference between them ( $\chi^2 = 3.59$ , ns), but respondents found that directional signs were less visible in these two stairwells than in either Stairwell A ( $\chi^2 = 7.32$ ,  $p < 0.05$ ) or Stairwell E ( $\chi^2 = 26.03$ ,  $p < 0.05$ ). Figure 19 shows the photoluminescent directional signs installed which combined the running-men and an arrow. These directional signs were positioned on every landing of the 3 photoluminescent stairwells.

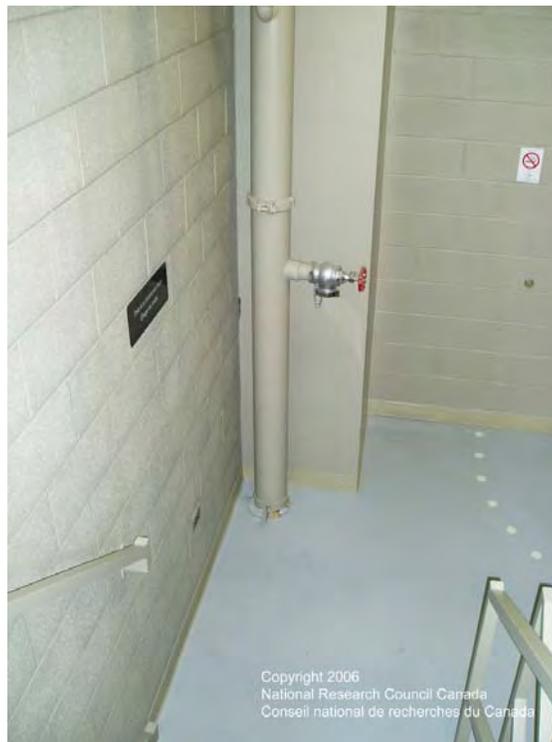
Figure 21: Water pipe obstacle in Stairwell C

There was no statistical difference (non significant (ns)) among stairwells for the marking of obstructions ( $\chi^2= 10.751(9)$ , ns), the identification of the crossover floor ( $\chi^2= 14.458(9)$ , ns) or the marking of the final exit ( $\chi^2= 12.304(9)$ , ns). These markings were the same in the 3 photoluminescent stairwells. In Stairwell C there was no marking for the water pipe standing at the edge of each landing which could become an obstruction, however it appears that evacuees in that stairwell did not notice this absence of marking; see Figure 21. It is possible that unless a person collides with an obstruction or has to change course to avoid an obstruction this element is not necessarily noticed. Crossover floor signs were photoluminescent in the 3 tested stairwells and were standard signs in Stairwell C. Respondents seemed not to have noticed, as evacuees did not re-enter or attempt to re-enter on a crossover floor during this evacuation drill. The final exit had received a special treatment in the 3 stairwells with photoluminescent markings, as they were all equipped with a doorframe marking of 1", door hardware marking and a sign indicating Final Exit. As the final flight of stairs was fully lit and the first person to exit the stairwell allowed the final exit door to automatically remain open, neither the photoluminescent markings or the lack of marking in Stairwell C were noticed.
